STM32WB50CG/30CE device errata

This document applies to STM32WB50CG/30CE devices and the device variants as stated in this page.

It gives a summary and a description of the device errata, with respect to the device datasheet and reference manual RM0471.

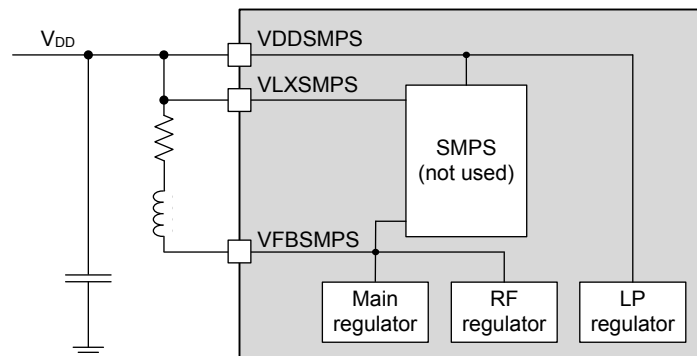
Figure 1. Workaround

The Hard Fault can be observed in case SYSCLK=HSE. Otherwise the risk is radio malfunction since clocked from HSE directly too.

The recommended inductor characteristics are the inductance 1.8 nH +/- 0.1 nH, self-resonance frequency of 6 Ghz +/-15 %, and rated current of 1000 mA. The resistor of 2.2 Ω recommended resistance must be dimensioned to dissipate 1 watt during 5 ns. Refer to [Minimal BOM for STM32WB Series microcontrollers \(AN5290\)](#) for more details.

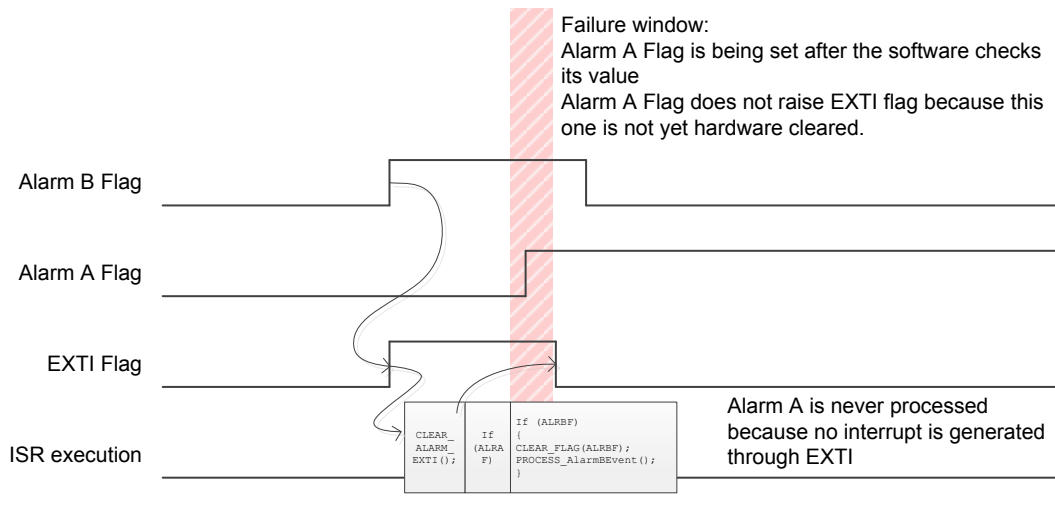
Figure 2. Masked RTC interrupt

The following code example and figure illustrate the failure mechanism: The Alarm A event is lost (fails to generate interrupt) as it occurs in the failure window, that is, after checking the Alarm A event flag but before the effective clear of the EXTI interrupt flag by hardware. The effective clear of the EXTI interrupt flag is delayed with respect to the software instruction to clear it.
