# ATtiny204/404

## ATtiny204/404 Silicon Errata and Data Sheet Clarification

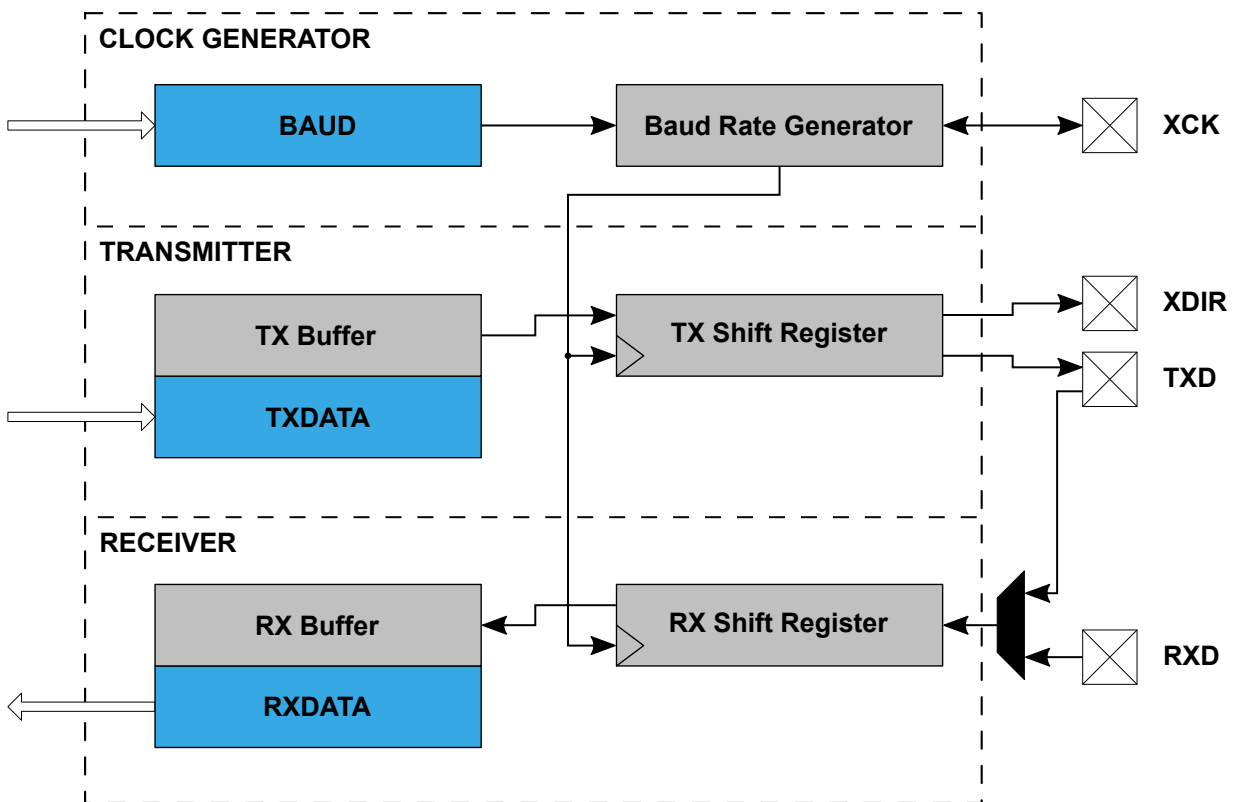
**Figure 3-1. Block Diagram**

The block diagram is missing that USART TX is double-buffered from figure 25-1 in the data sheet. Added **TX Buffer** is shown below.

The transmitter consists of a **two-level** write buffer.

The data transmission is initiated by loading the **Transmit Data (USARTn.TXDATAL and USARTn.TXDATAH)** registers with the data to be sent. The data in the **Transmit Data registers are moved to the TX Buffer** once it is empty and onwards to the Shift register once it is empty and ready to send a new frame.
