Table of Contents

This document describes the known exceptions to the functional and performance specifications to TI CMOS Radar Devices (AWR1642).

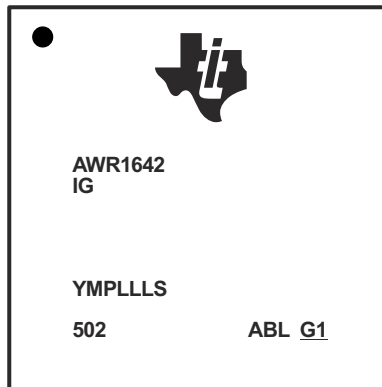
Figure 3-1 shows an example of the AWR1642 Radar Device's package symbolization.

Figure 3-1. Example of Device Part Markings

This identifying number contains the following information:
